Nod Road Landfill

Initial Site Assessment & Comprehensive Site Assessment Scope of Work

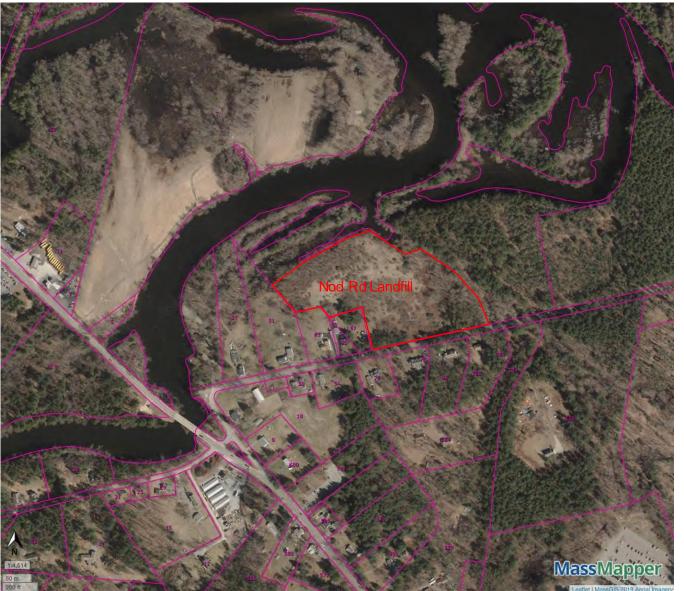
Property Tax Parcels

Located on a portion of Parcel 216-70

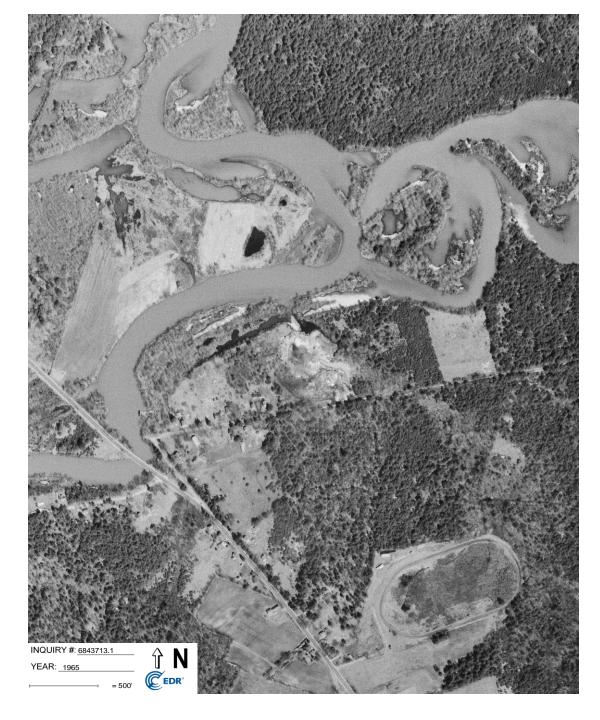
1976 Closure Plan

- Aerial Photograph shows activity on the parcel as early as 1938.
- 1944 USGS Map shows driveway access.
- By 1965, ½ the area had been disturbed.
- By 1975 landfill is at is current size.
- Capping plan approved by MADPH in 1976.
- 1977 landfill appears to be graded and capped except for a strip along the Nashua River.
- Approved closure plan did not include any environmental monitoring.

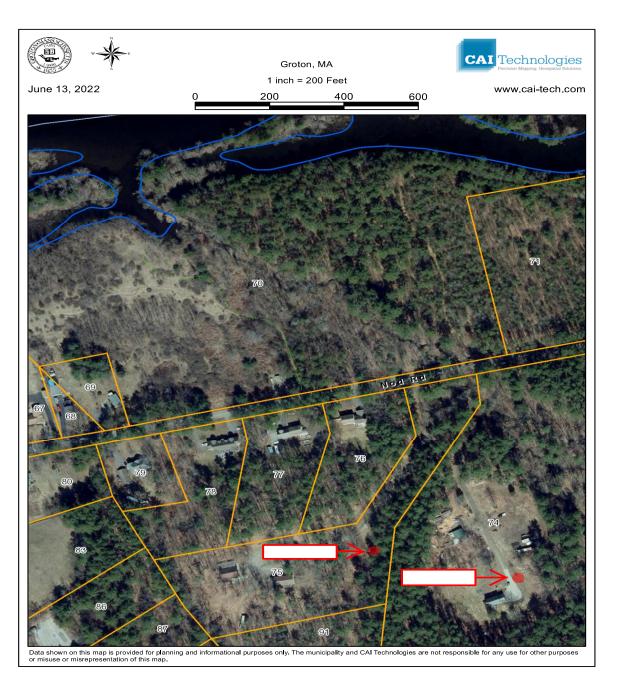
Closest Private Wells

- No Public Drinking Water Supplies
- Residential Dwellings to the west and south
- No Private Domestic Wells
- No Day Care Centers
- No Schools
- No Elderly Housing
- No Hospitals
- On-site hikers

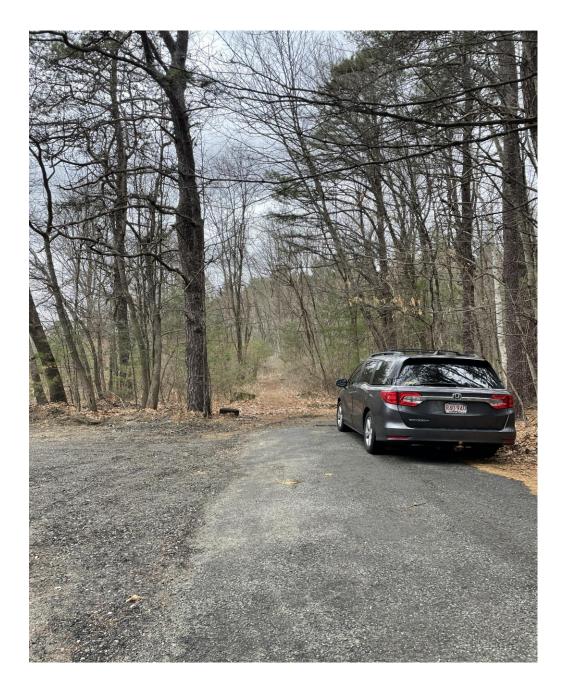
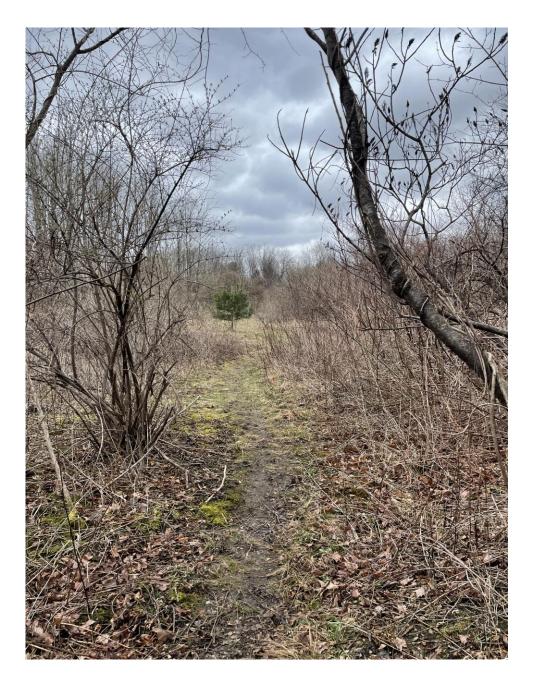
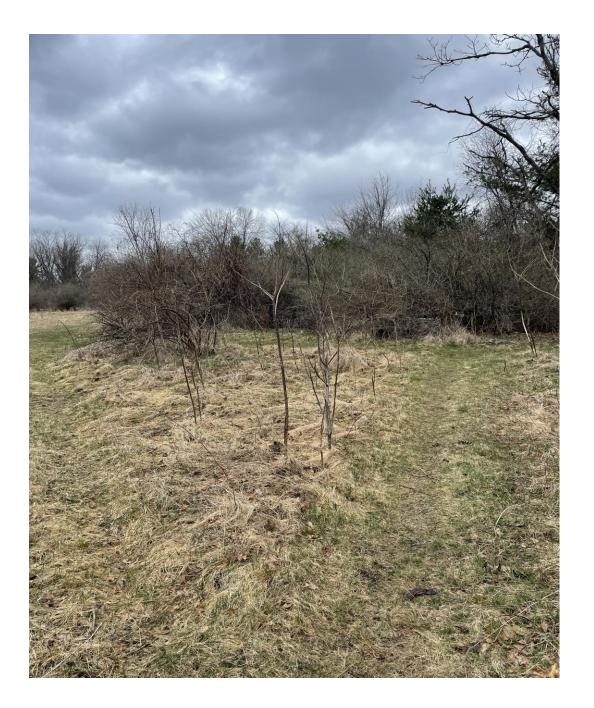
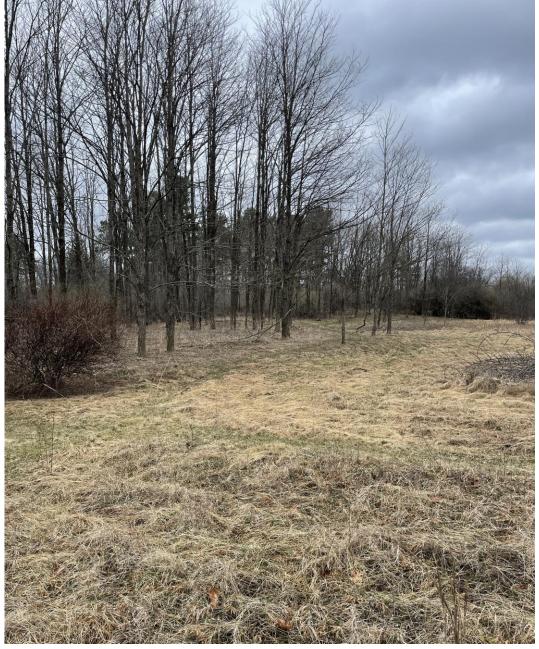
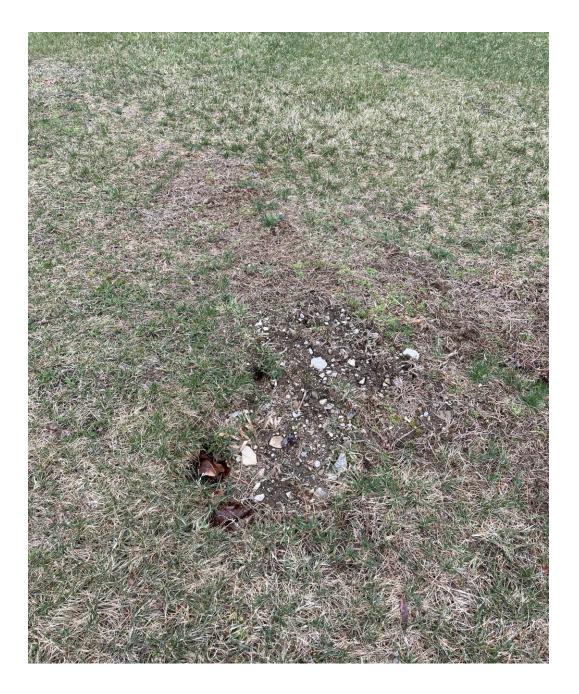
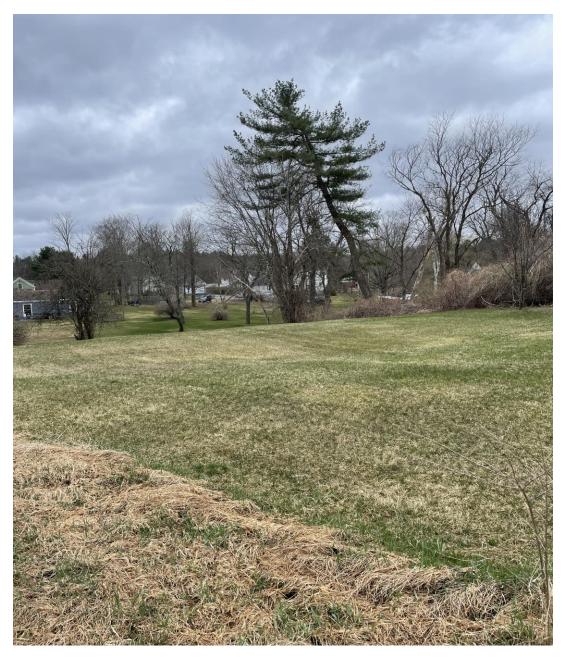
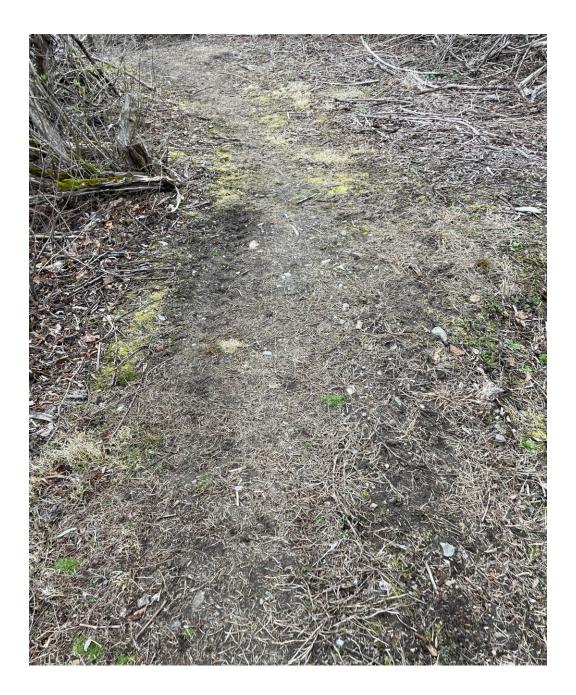
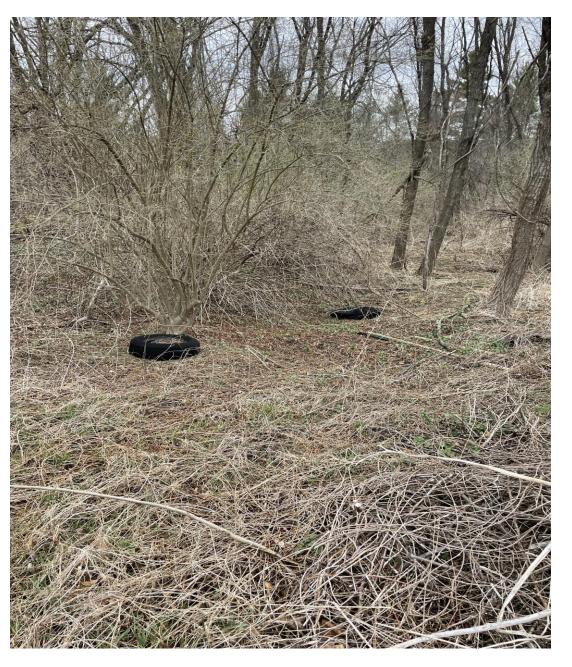
April Site Inspection

- Parking is available off Nod Road by the Pump station.
- Landfill Cap is vegetated with heavy ground cover, bushes and small trees.
- Walking trail leads to top of landfill and foot bridge to state forest.
- Top of landfill has dense grass cover.
- No erosion observed. One animal borrow.
- Random tire and other pieces of solid waste.
- Neighbors mow a portion of the side slope.
- One neighbor accesses the landfill via ATV trail.

• Turning right trail leads to foot bridge crossing Nod Brook on to Conservation land and the State Forest.

- Post signage in parking area and along property access points notifying people that it a landfill.
- Prohibit digging or disturbing the cap.
- Prohibit use by motorized vehicles.
- Prohibit access to the water from the Landfill.
- Conduct annual inspections to ensure cap integrity.
- For any uses beyond a walking path a Comprehensive Site Assessment followed by a Corrective Action Alternative Design would be required.

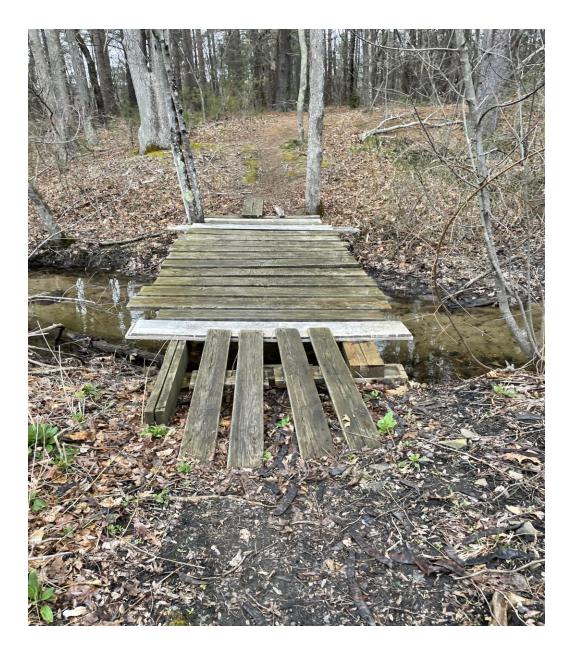
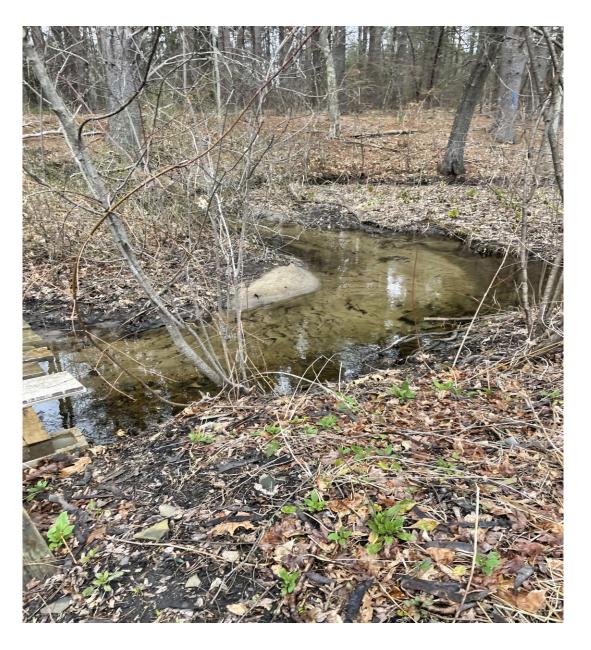
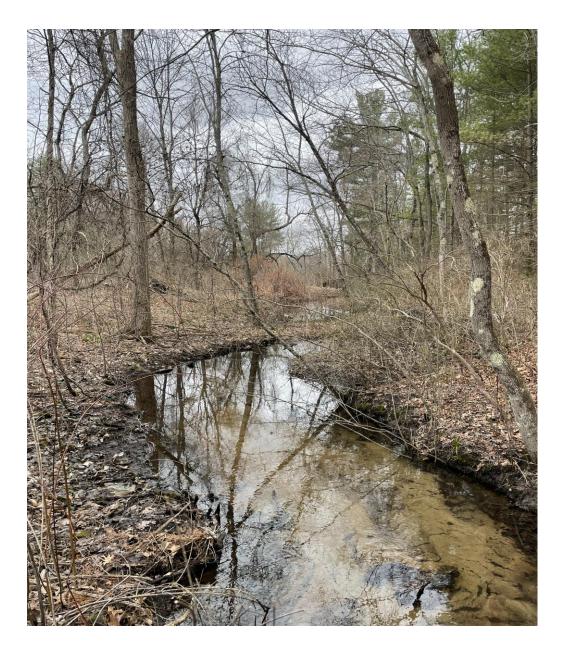
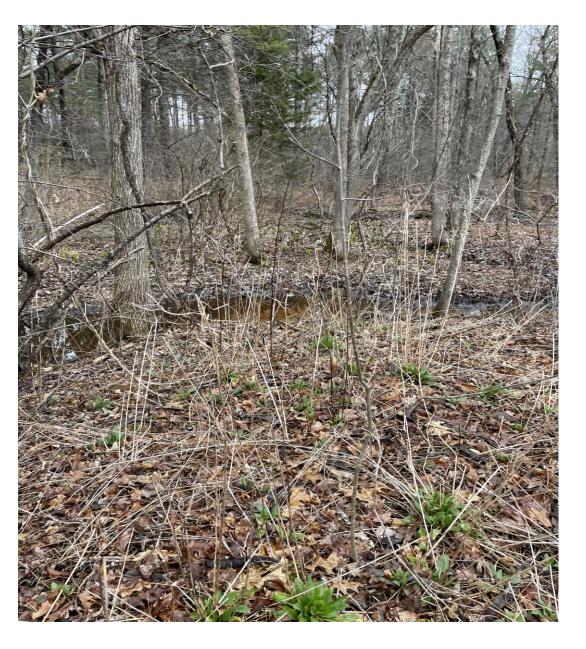
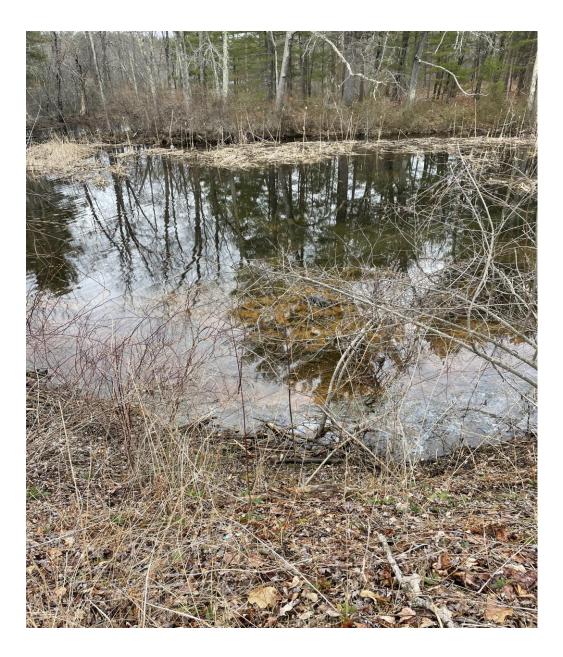
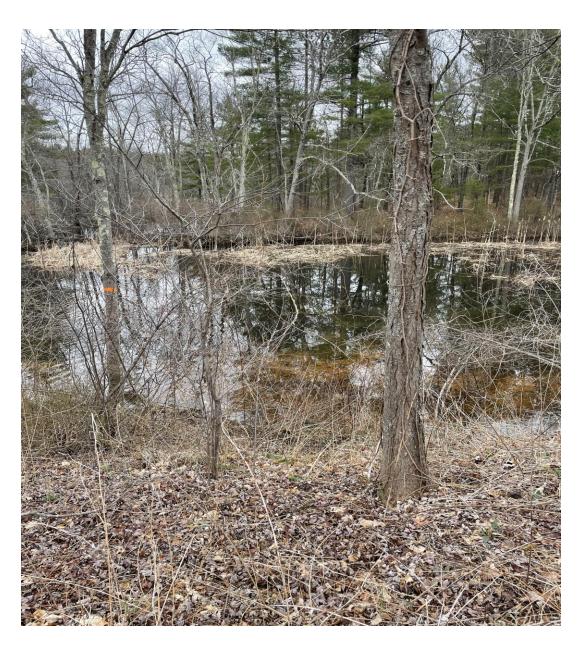
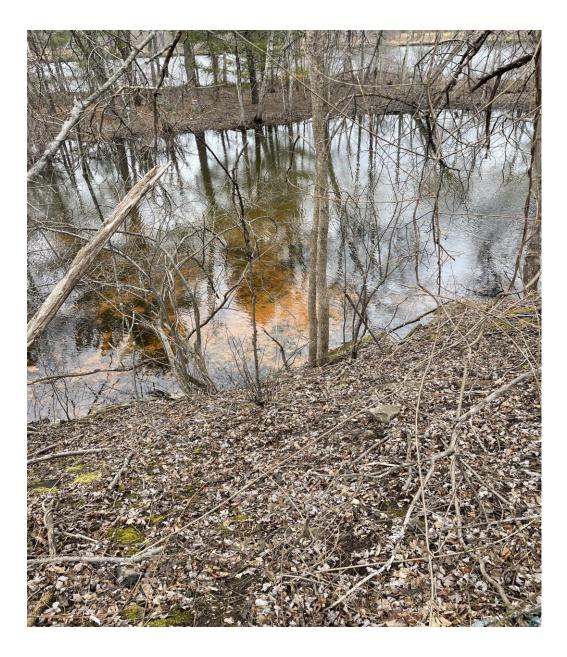
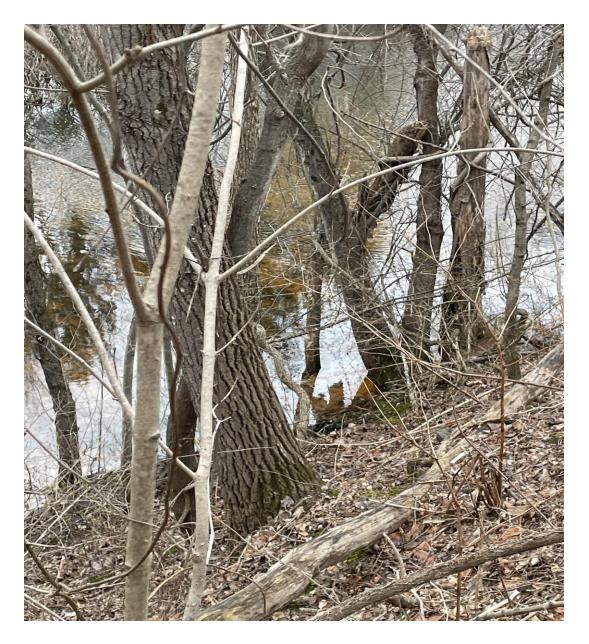
- No leachate breakouts were observed in Nod Brook east of bridge.
- Visual evidence of leachate breakouts west of Nod Brook and in Oxbow lake off Nashua River.
- Leachate evident by iron staining.

- The landfill is located in an ACEC where there is rare and endangered species habitat.
- Wetland resource areas are present along the northern and eastern boundaries.
- Leachate breakouts with iron staining are visible at the toe of slope on the north and east sides.
- Breakouts are immediately adjacent to the landfill and do not extend out into the surface water features.
- There has been no environmental monitoring.

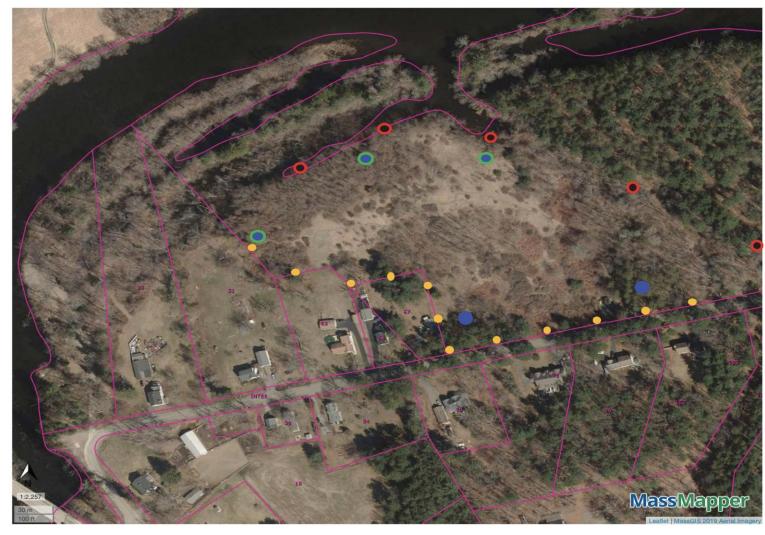
Figure 5

- Landfill Gas Probes
- Surface Water/ Sediment Locations
- Monitoring Well Couplet
- Water Table
 Monitoring Well

- Identification of wetland resources by wetland scientist.
- Installation and sampling of ground water monitoring wells.
- Hydraulic conductivity testing of aquifer.
- Establishing and sampling surface water and sediment sampling locations.
- Installing landfill gas monitoring wells.
- Excavation of test pits around perimeter and through the cap.
- Update base map.
- Report preparation.
